INVENTORY OF MONUMENTS AT PAGAN

Volume One
Monuments 1-255

PIERRE PICHARD

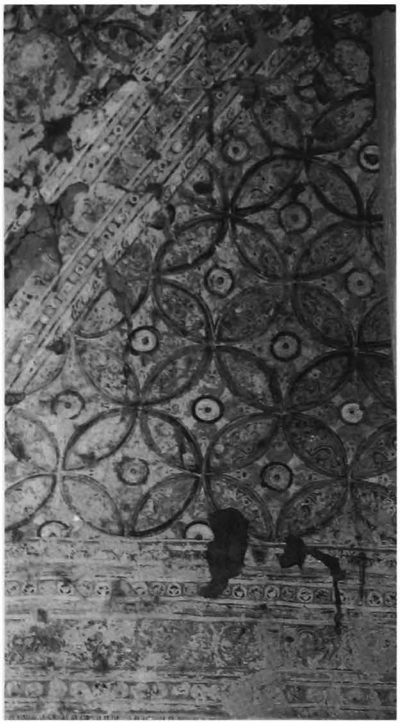
359 h - Shrine vault and central pillar, from north

- given the small size of the central pillar as compared with customary solid cores and the profile of the corridor vault, this temple seems to have been originally designed with a central shrine, 5.30 x 5.40 m, while the central pillar had soon to be added to support the square tower over the apex of the cloister vault. A scaffolding would be necessary to clarify this point.

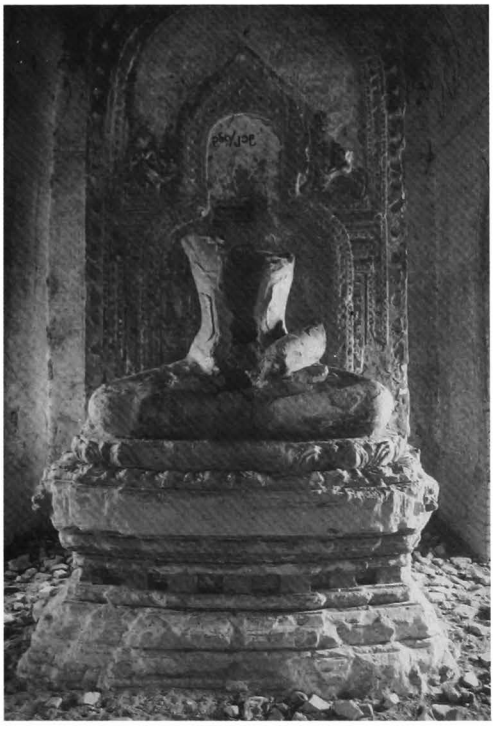
6 images
- 1 seated Buddha (damaged and headless), facing east, against a screen wall.
- 1 reclining Buddha (destroyed), on west face of screen wall.

360 g - Screen wall and image, from east

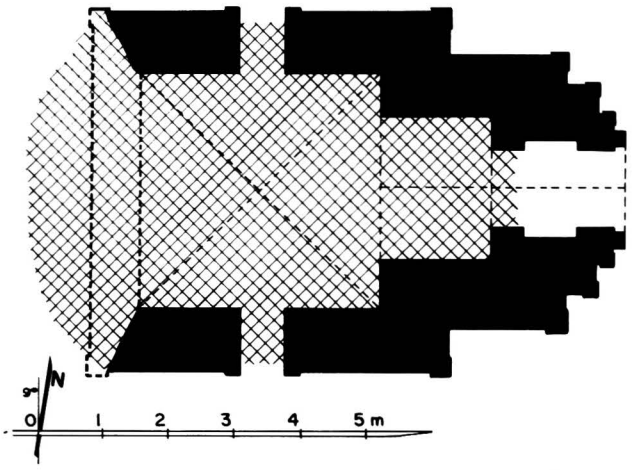
366 b - From north-east

5 present condition
- ruined.
- ground floor buried under debris.
- west and south walls, vault and upper parts collapsed during the 8 July 1975 earthquake.

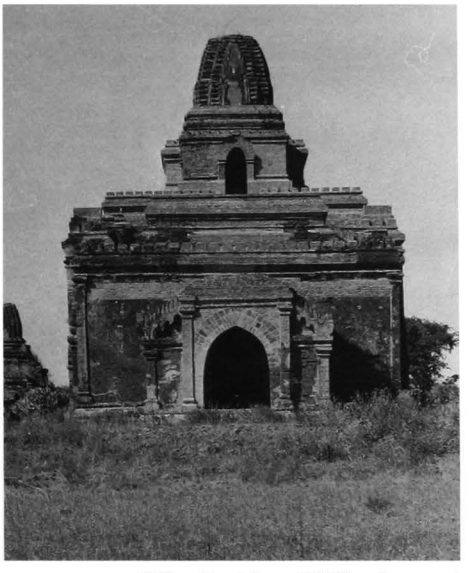
369 c- East face (1990), after repair

5 present condition
- regularly maintained.
- repaired (north wall and corridor vault rebuilt) and strengthened (Const. Corp.) 1987-9.

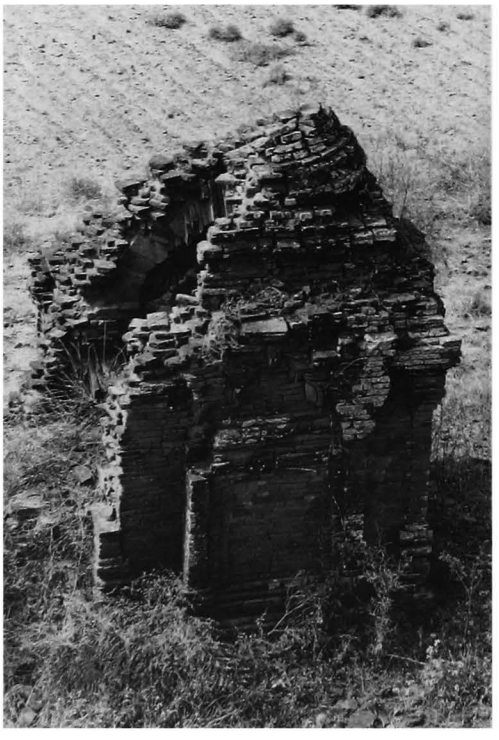
370 b - From north

5 present condition
- half-ruined.
- upper parts nearly destroyed.
- east part collapsed.

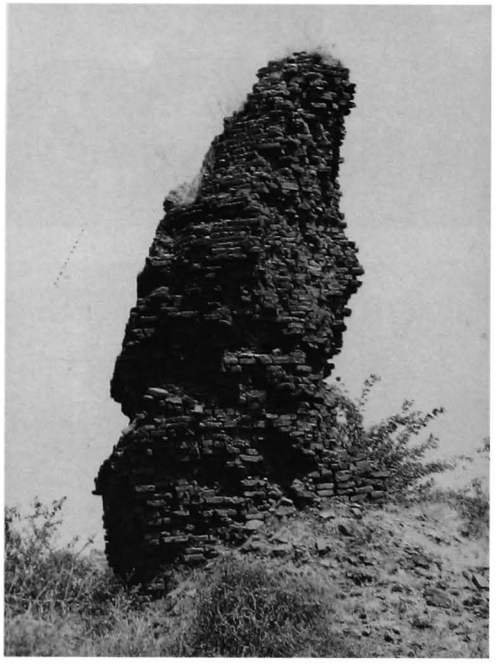
372 c - From south

5 present condition
- no maintenance.
- half-ruined and endangered.
- base disintegrated.
- upper parts nearly destroyed.

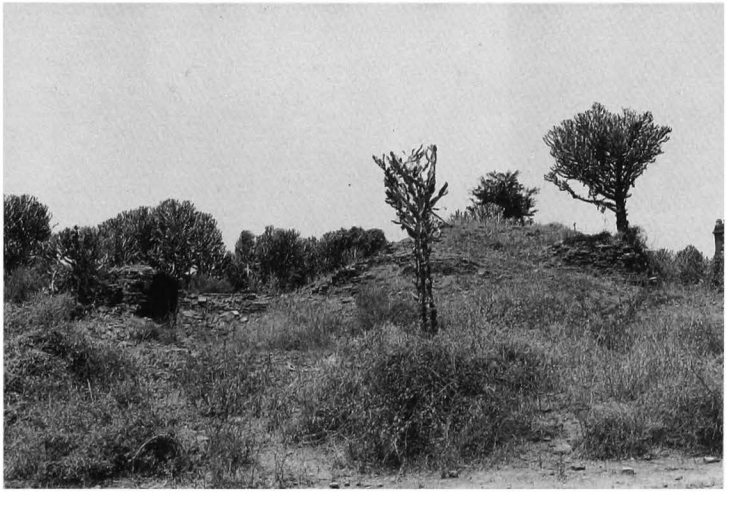
375 b - From east

5 present condition
- ruined and unexcavated.
- ground floor buried under debris.

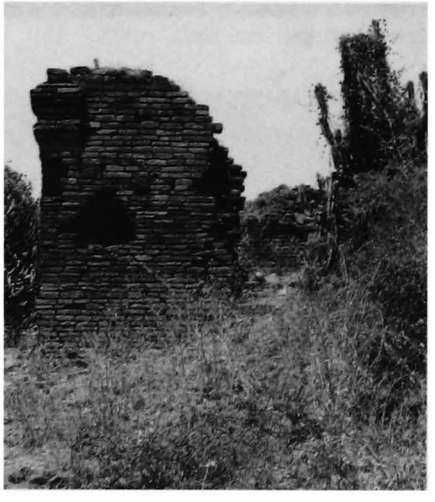
376 b - From east

5 present condition
- ruined.
- no more trace of vaults.
- ground floor buried under debris.

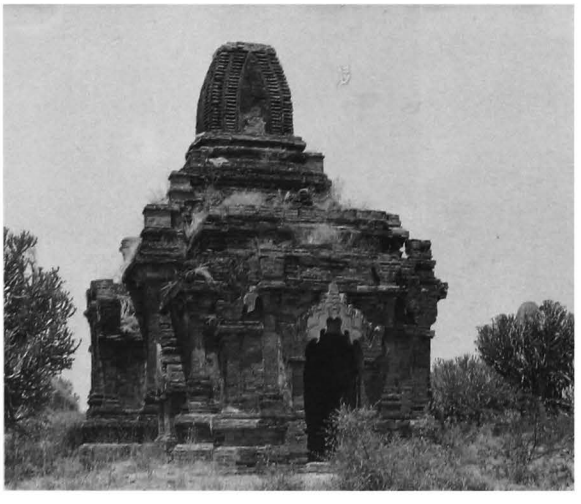
5 present condition
- repaired.
- brick grilles built by Arch. Dept.

378 c - East face

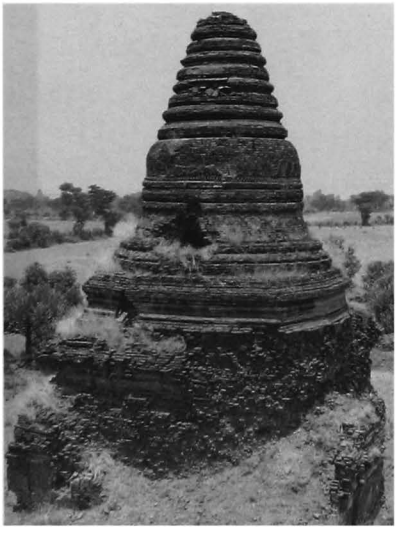
5 present condition
- no maintenance.
- base and terraces heavily damaged, east face collapsed.

379 c - From south-east

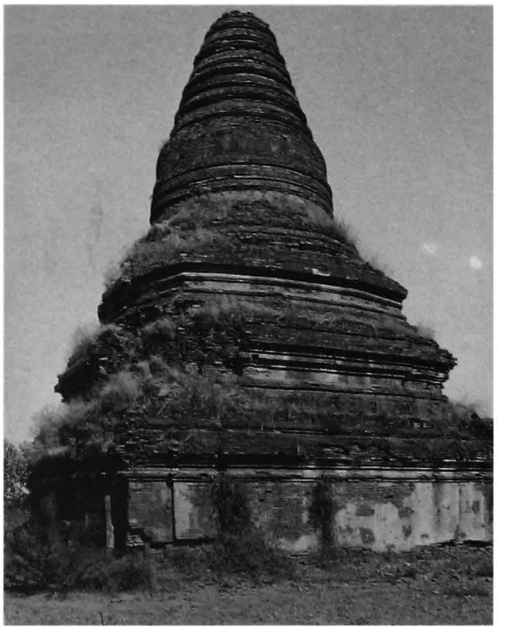
379 d - From north-west

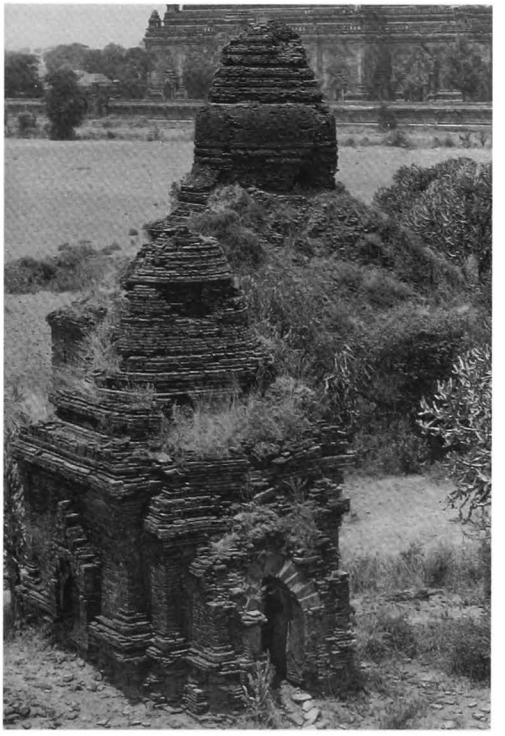
5 present condition
- no maintenance.
- base disintegrated.
- east porch collapsed.

382 d - From south-east, together with 383 and 1812

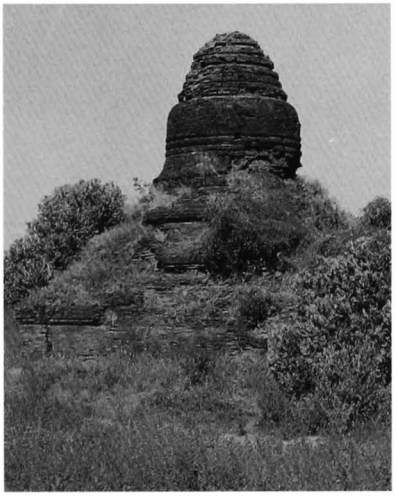
5 present condition
- no maintenance.
- terraces heavily damaged.

383 b - From south

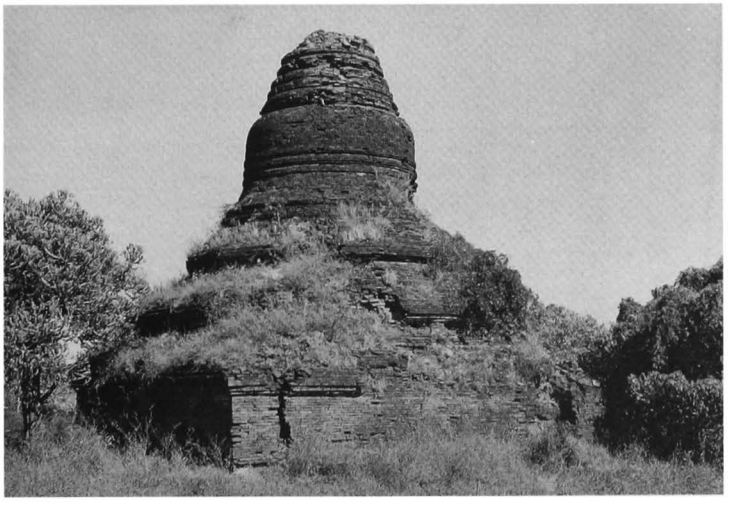
383 c - From south-west

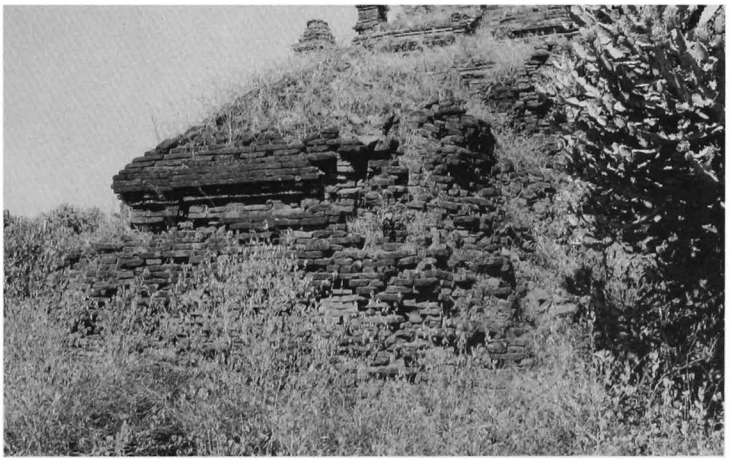
5 present condition
- no maintenance.
- ruined.
- base and terraces disintegrated.

385 c - From south-east

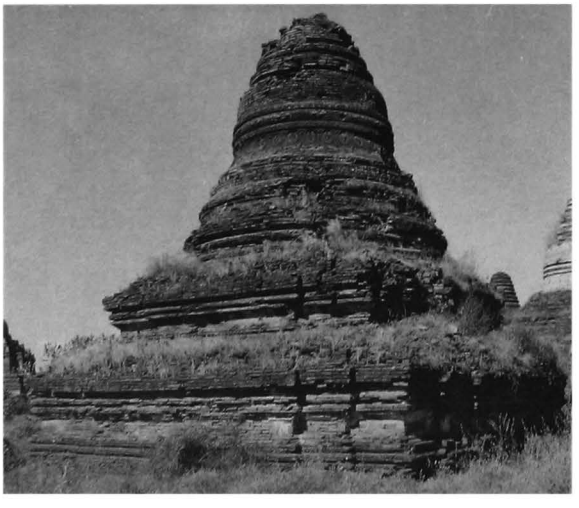
5 present condition
- no maintenance.
- terraces damaged.

388 b - From south-east

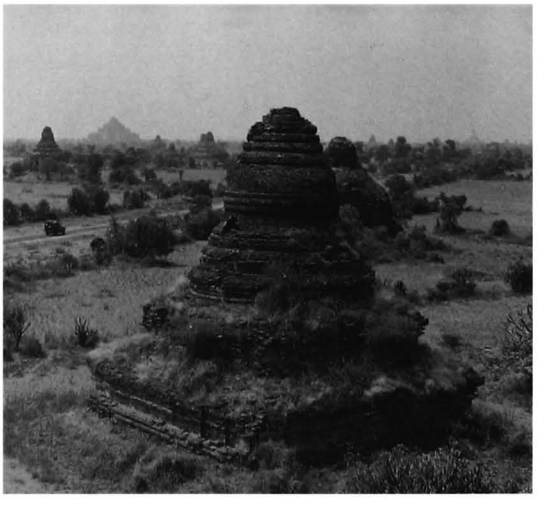
388 c - From north-east

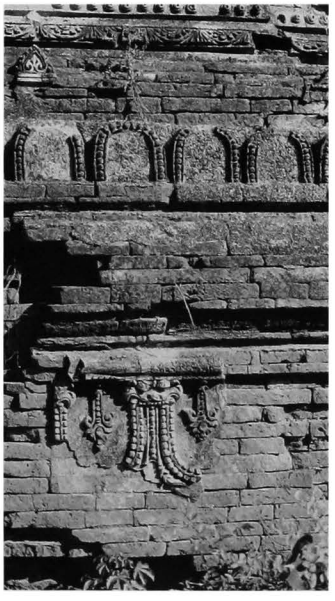
5 present condition
- no maintenance.
- upper parts nearly destroyed.

389 c - West face, detail

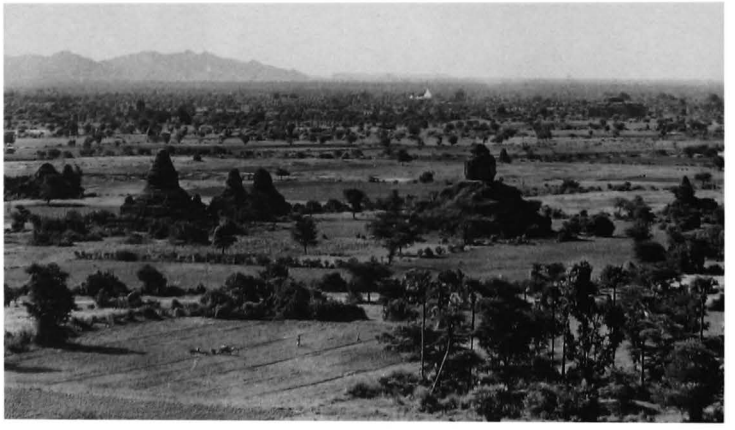
5 present condition
- no maintenance.
- stairways ruined.
- upper parts endangered.

394 b - From north-west, together with 397

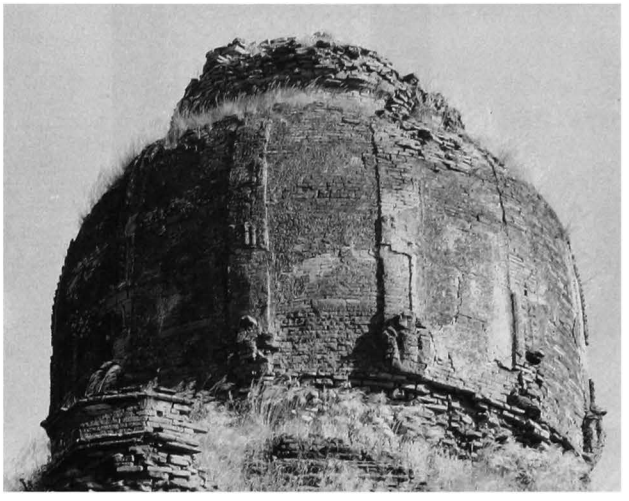
394 d - Dome, from north-west

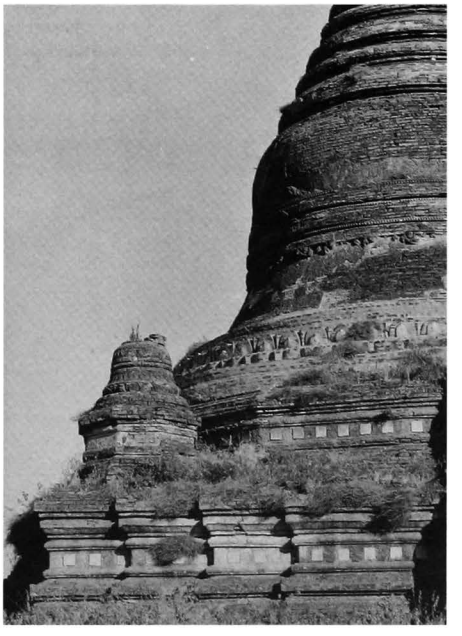
397 d - Upper parts, north-west corner, from west

5 present condition
- no maintenance.

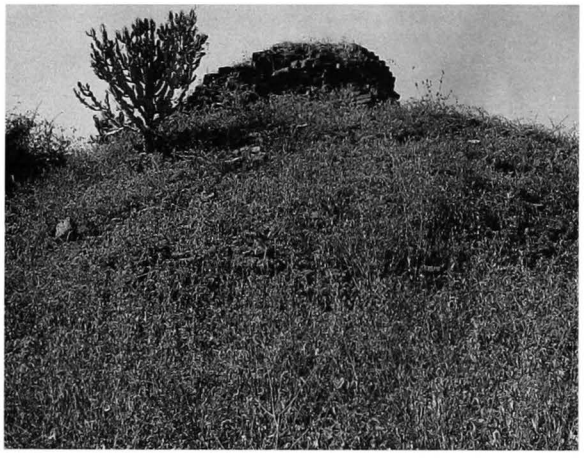
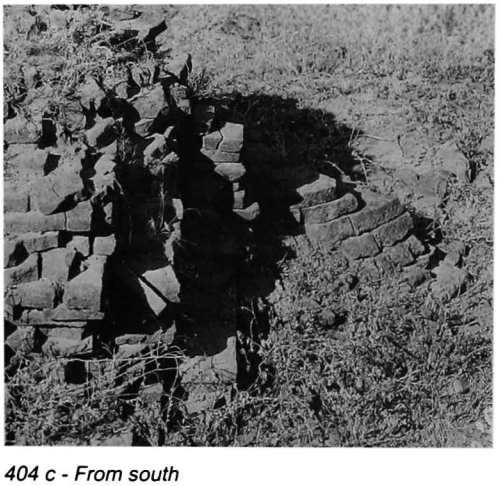
404 b - From east

5 present condition
- ruined.
- base and terraces disintegrated and buried under debris.
- upper parts collapsed.

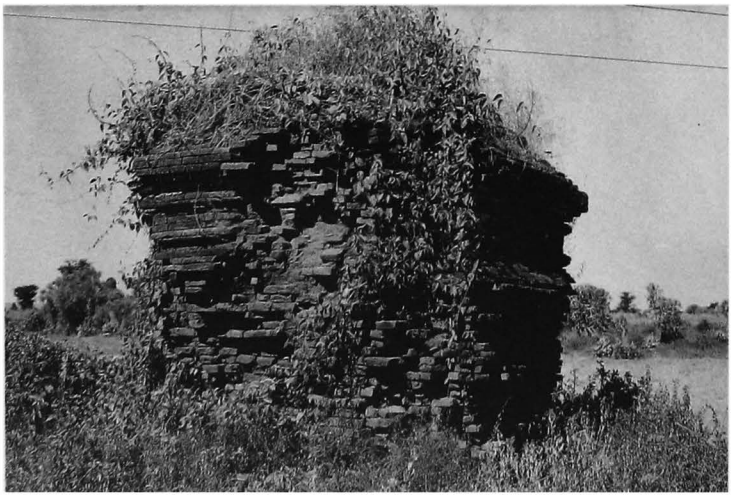
407 b - From south-west, together with 408

5 present condition
- ruined.

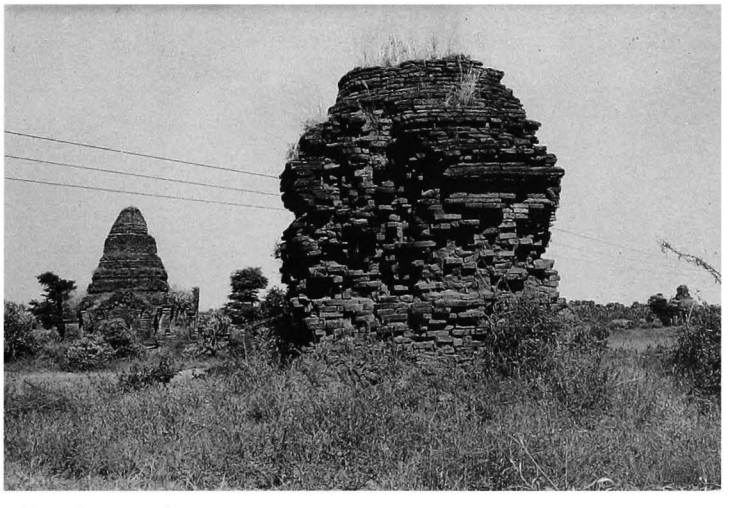
408 b - From south

5 present condition
- ruined.

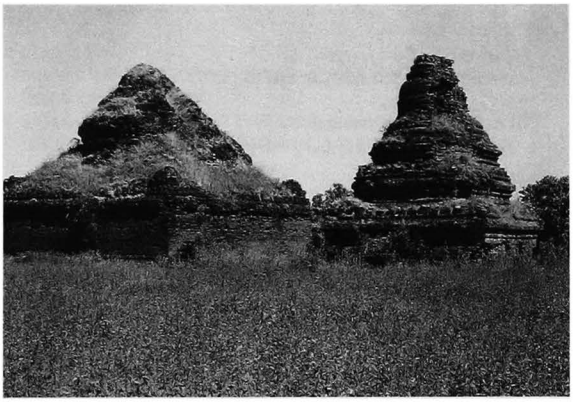
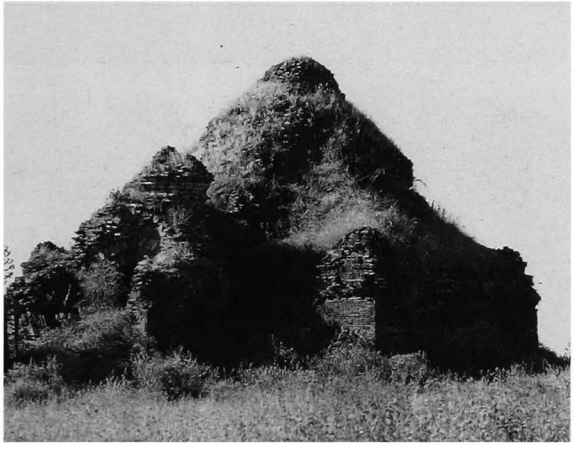
410 b - From south-west, together with 409

5 present condition
- half-ruined.
- upper parts badly damaged.

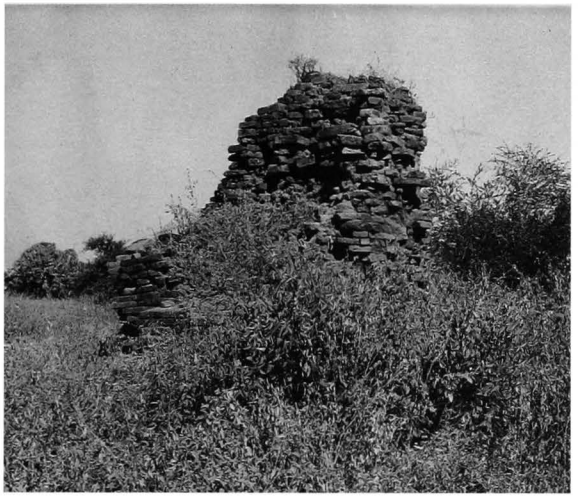
415 b - From south-east

5 present condition
- ruined.
- upper parts collapsed.

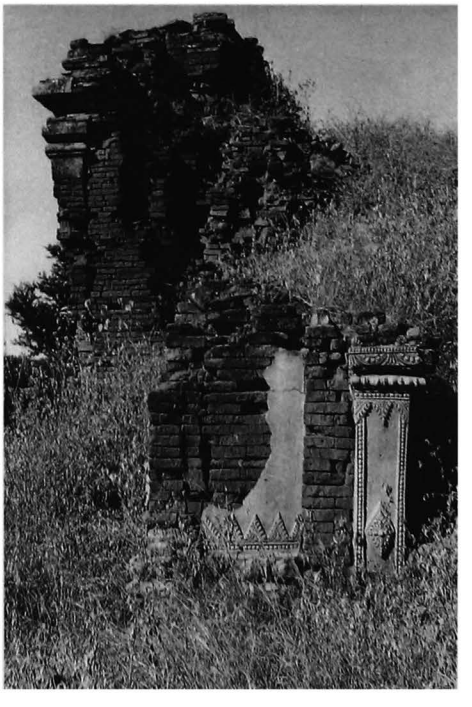
416 c - From north-east

5 present condition
- ruined.
- vaults and upper parts collapsed.
- ground floor buried under debris.

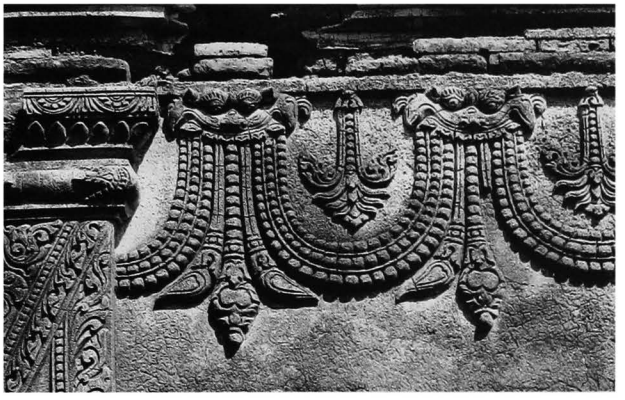
418 f - South face, south-west corner, detail of cornice and pilaster

5 present condition
- half-ruined.
- vaults and upper parts collapsed.

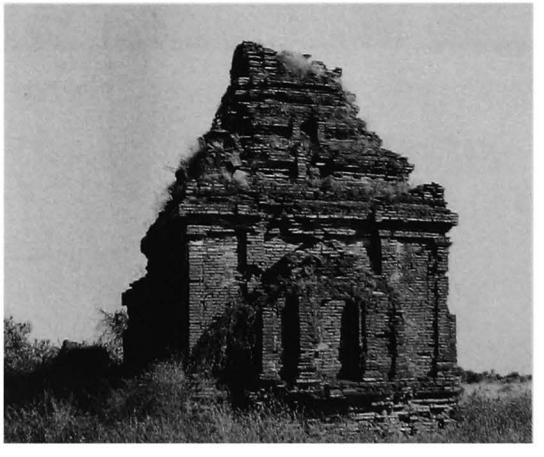
420 c - South face

5 present condition
- no maintenance.
- east porch collapsed.
- upper parts heavily damaged.

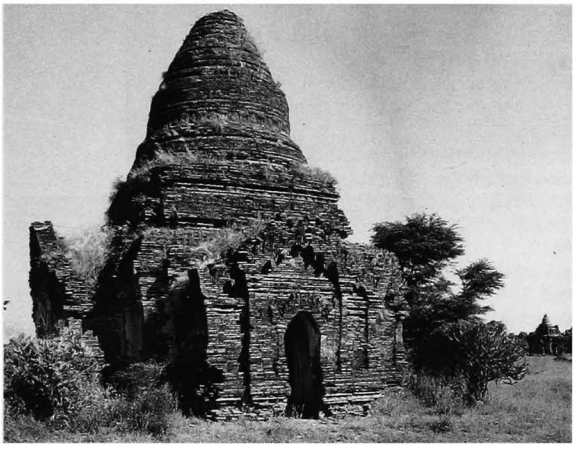
421 b - From south-west

5 present condition
- no maintenance.
- base disintegrating.

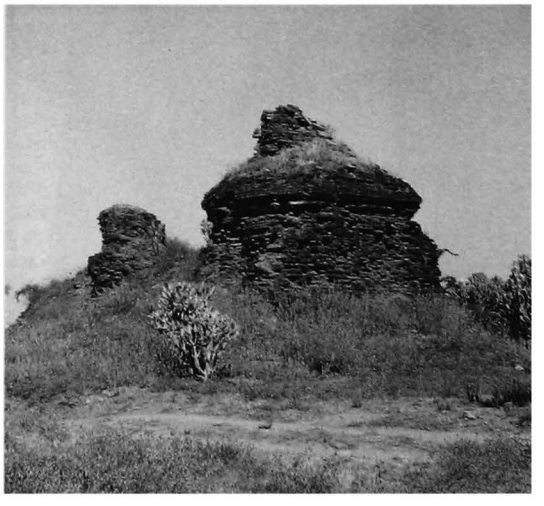
422 c - From south-west, together with 404

5 present condition
- ruined.
- base disintegrated.
- upper parts collapsed.

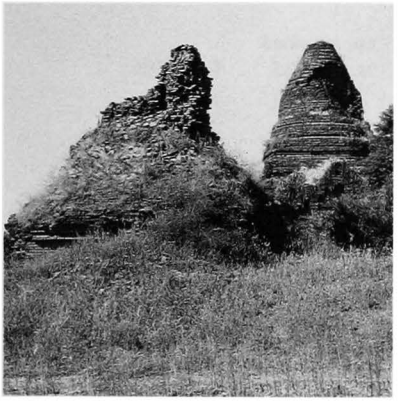
423 b - From east, together with 421

5 present condition
- half-ruined.
- base and terraces disintegrated.
- upper parts nearly destroyed.

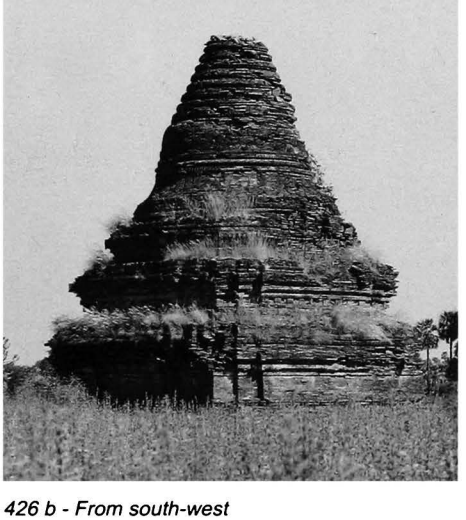
426 b - From south-west

5 present condition
- no maintenance.

7 decoration
- stucco mouldings, still in place: 30%.
- plain stucco mouldings on base and terraces.
- ornate waistband and frieze with ogre heads around dome.

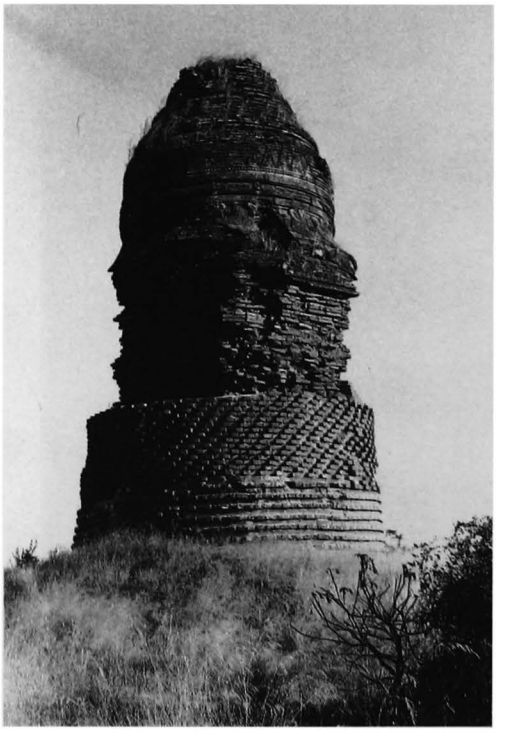
428 c - From north (1987), after repair

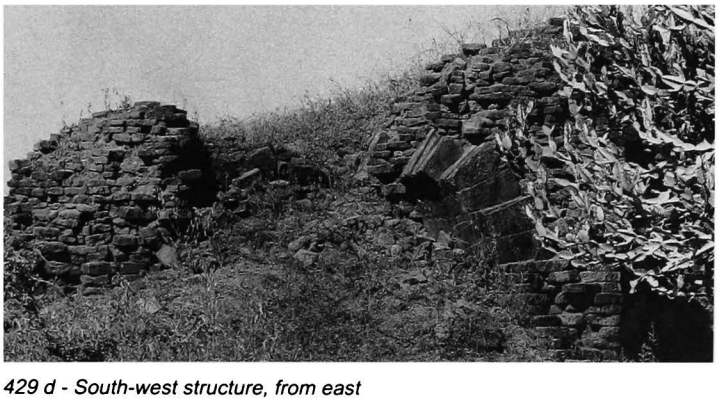
5 present condition
- ruined.

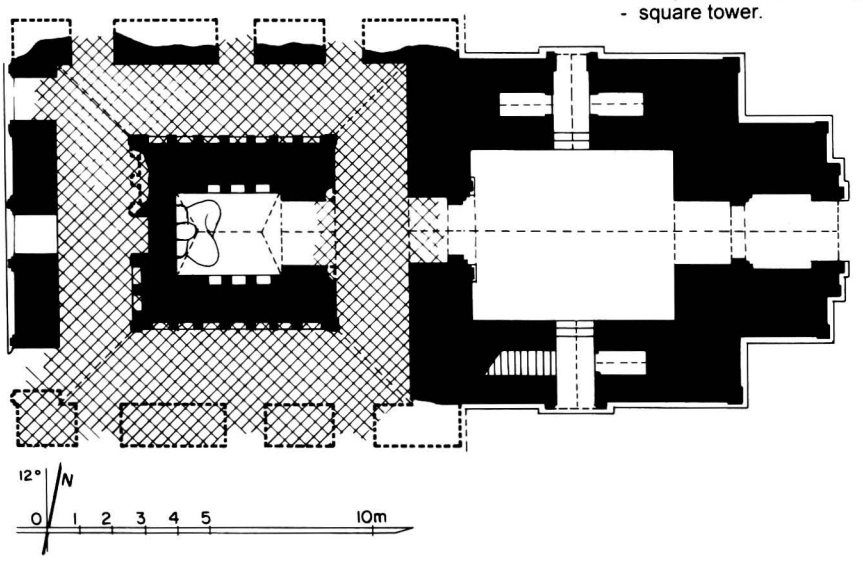
5 present condition
- half-ruined.
- debris cleared 1925.
- vault of east corridor collapsed during the 1975 earthquake.
- tower collapsed 1986.
- ground floor buried under debris.
- west wall endangered, leaning outwards.

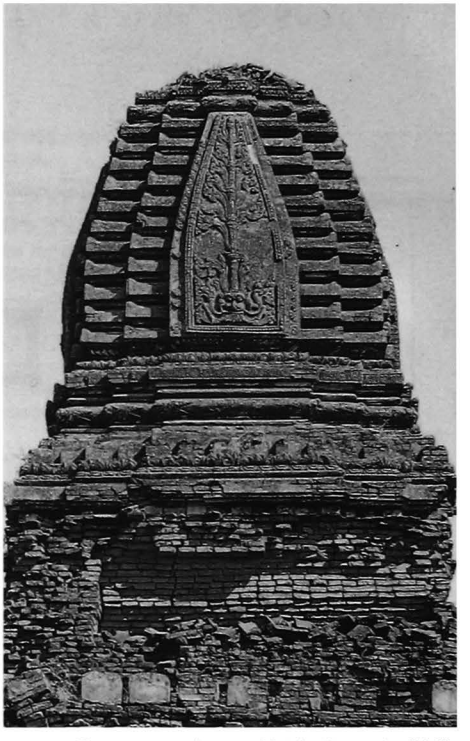
433 e - Tower, west face, 1984 (collapsed 1986)

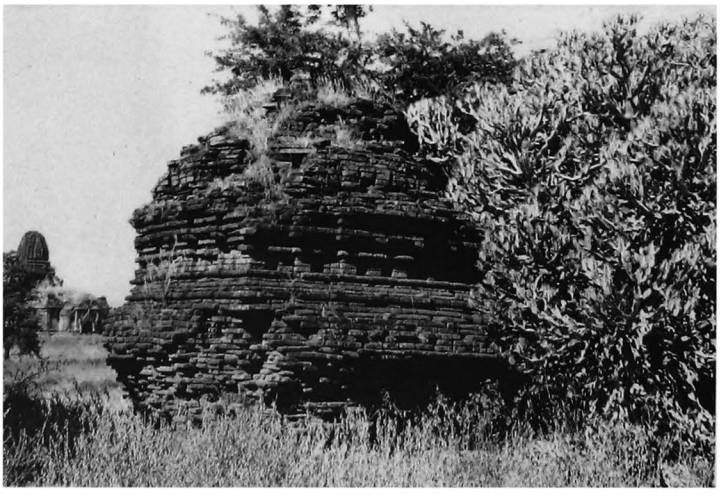
435 b - East face, from south-east

5 present condition
- half-ruined.
- base and terraces disintegrated.
- upper parts collapsed.

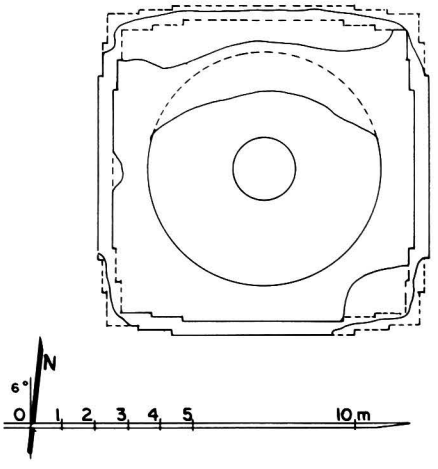
444 a - Plan

5 present condition
- no maintenance.
- terraces disintegrated.
- upper parts heavily damaged.

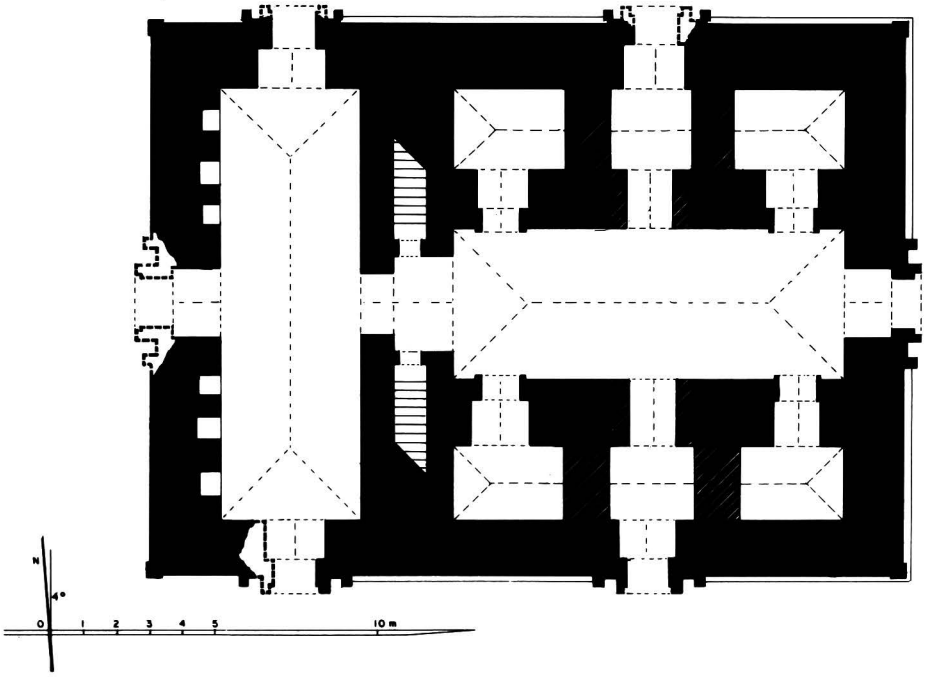
448 b - East face (1984)

5 present condition
- western part collapsed.
- vaults of upper floor collapsed.
- ground floor partly buried under debris.
- structure heavily cracked and worsened by the 1975 earthquake.
- cleared, repaired and strengthened (PW) 1991-3.

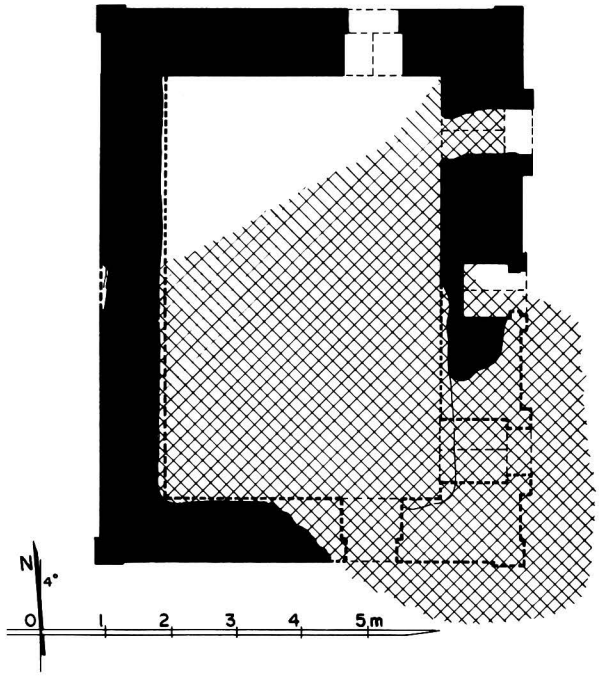
455 a - Plan

5 present condition
- ruined.
- vault and roof collapsed.
- ground floor buried under debris.

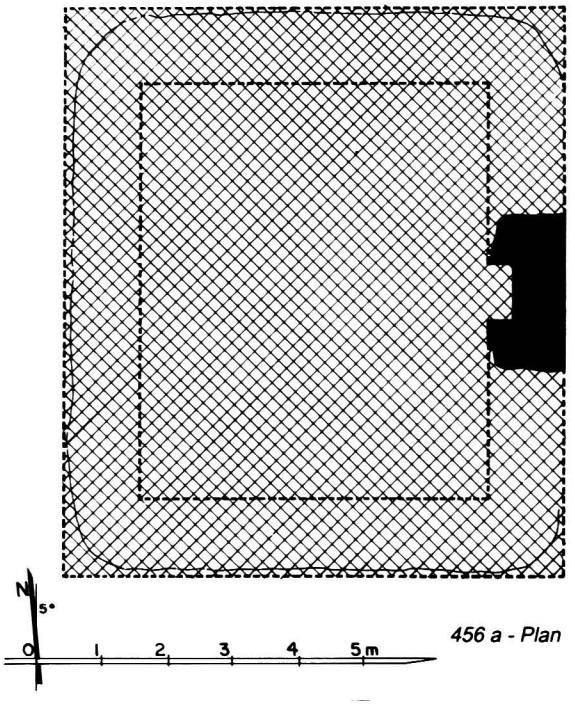
456 a - Plan

5 present condition
- ruined.
- ground floor buried under debris.
- only part of east wall remains.

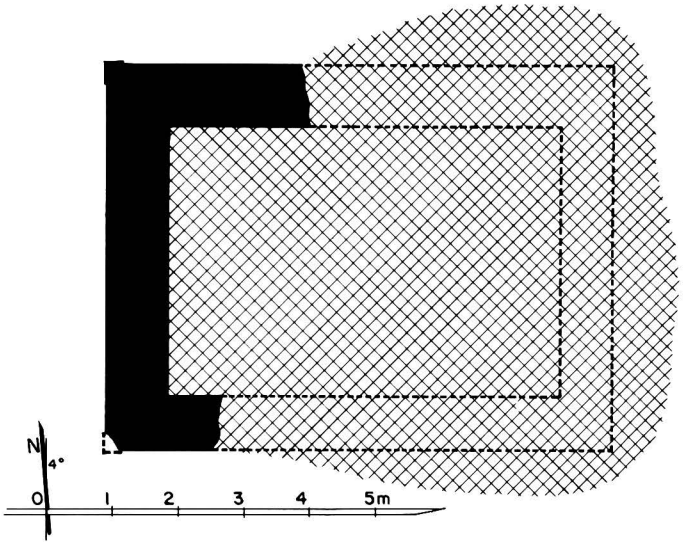
457 a - Plan

5 present condition
- ruined.
- ground floor buried under debris.
- only west wall remains.

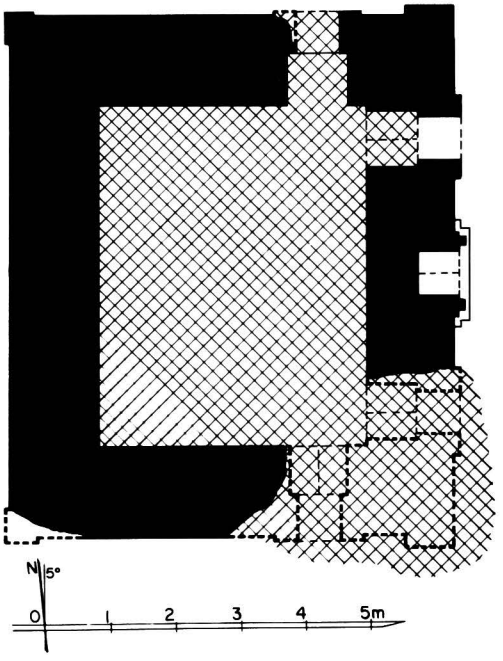
458 a - Plan

5 present condition
- ruined.
- vault and roof collapsed.
- ground floor buried under debris.

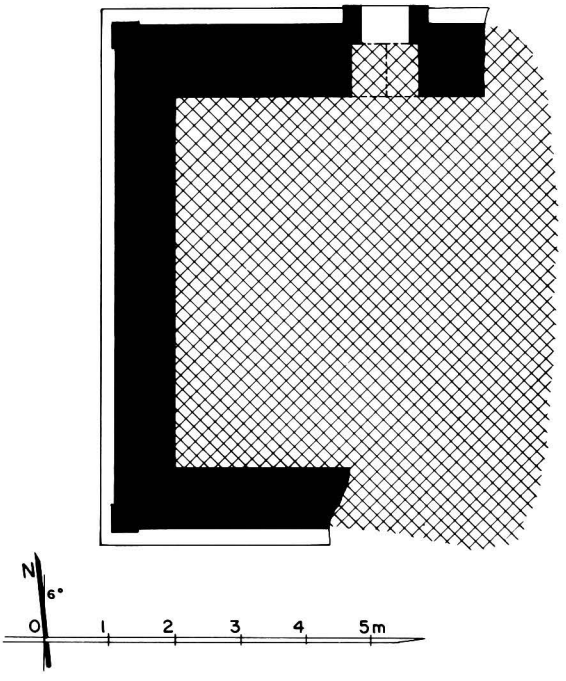
459 a - Plan

5 present condition
- ruined.
- east wall, vault and roof collapsed.
- ground floor buried under debris.

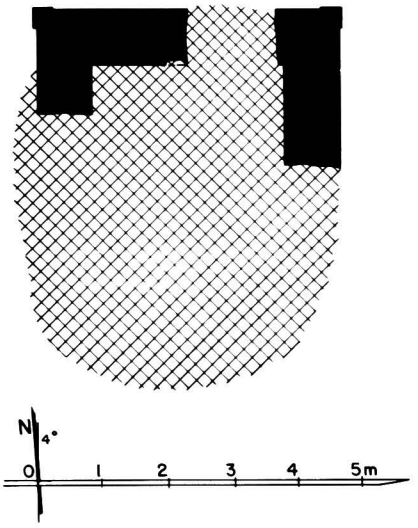
460 a - Plan

5 present condition
- ruined.
- vault and roof collapsed.
- ground floor buried under debris.
- only north part remains.

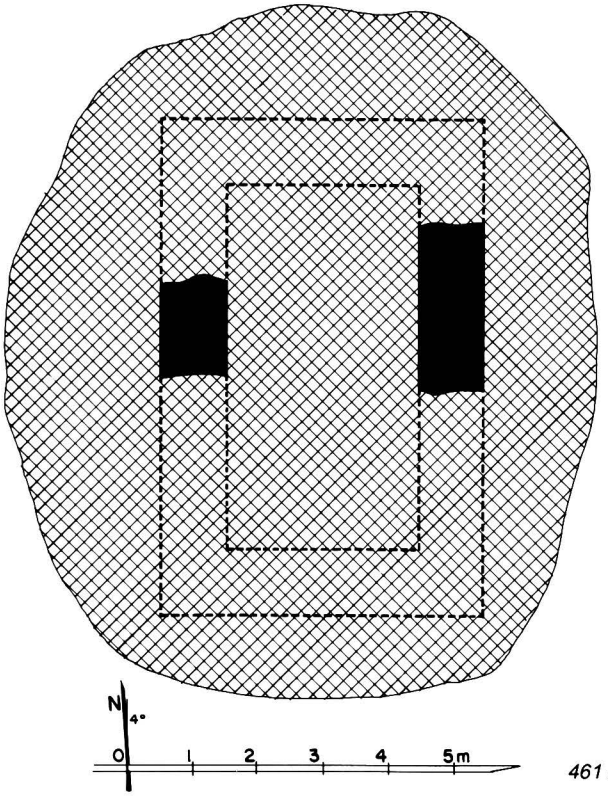
461 a - Plan

5 present condition
- ruined.
- walls, vault and roof collapsed.
- ground floor buried under debris.

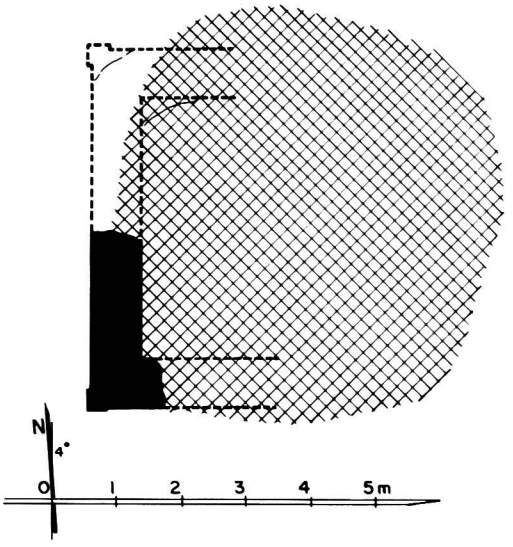
462 a - Plan

5 present condition
- ruined.
- walls, vault and roof collapsed.
- ground floor buried under debris.
- only south-west corner remains.

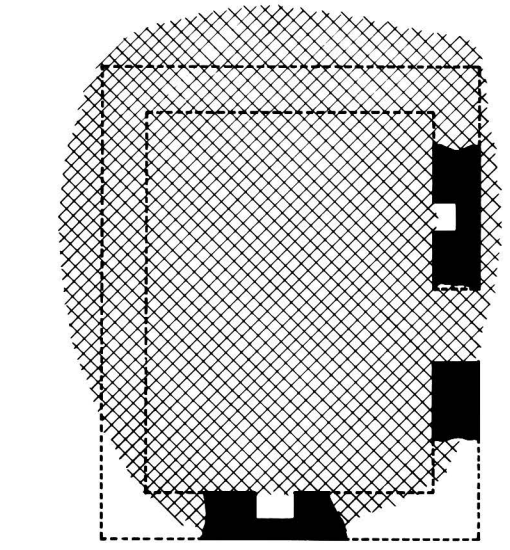
463 a - Plan

5 present condition
- ruined.
- vault and roof collapsed.
- ground floor buried under debris.

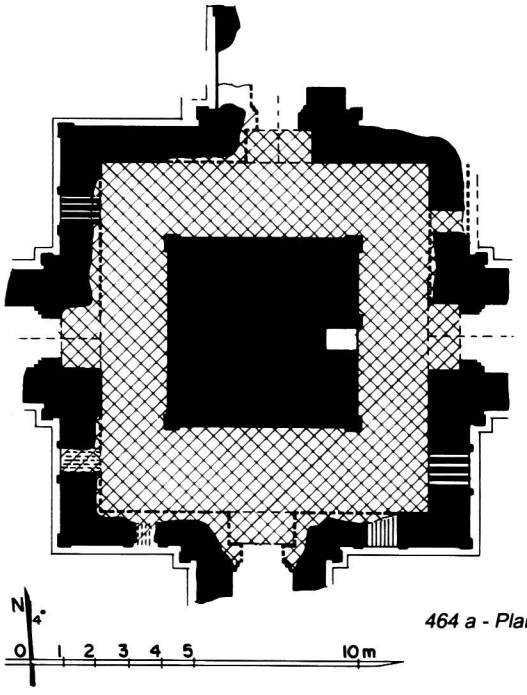
464 a - Plan

5 present condition
- half-ruined.
- foreparts collapsed.
- most vaults collapsed.
- upper parts collapsed.
- structure severely cracked.
- ground floor buried under debris.

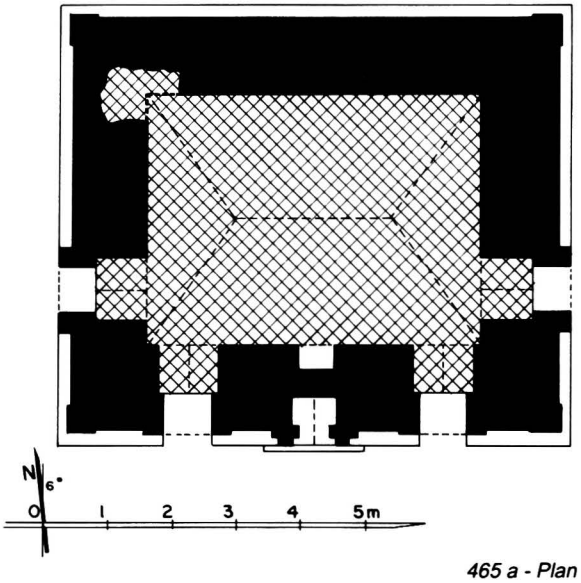
465 a - Plan

5 present condition
- half-ruined.
- vault and roof mostly collapsed.

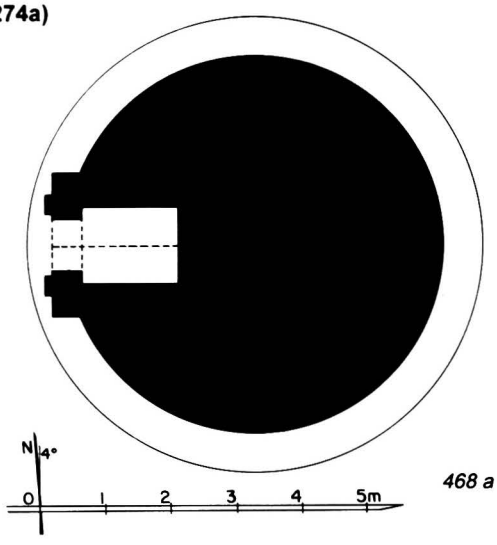
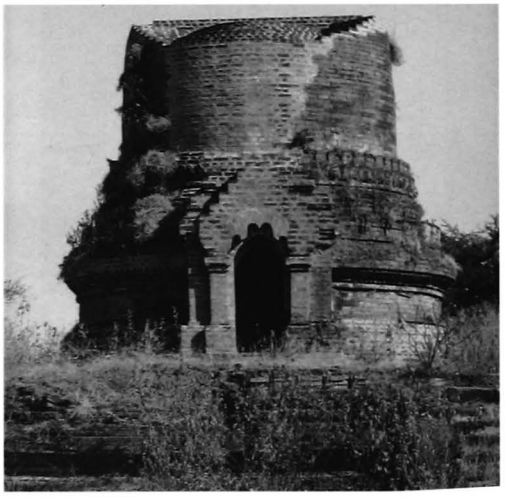
468 a - Plan

5 present condition
- regularly maintained.
- upper parts collapsed.
- repaired.

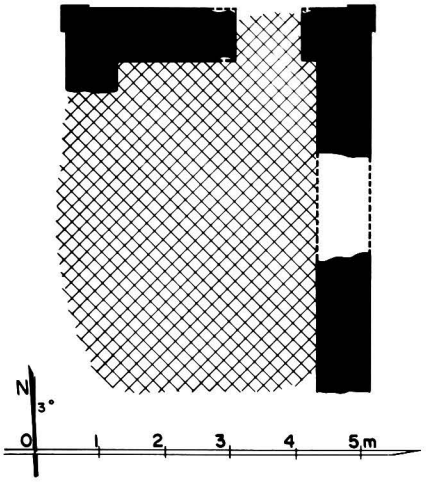
469 a - Plan

5 present condition
- ruined.
- vault and roof collapsed.
- ground floor buried under debris.

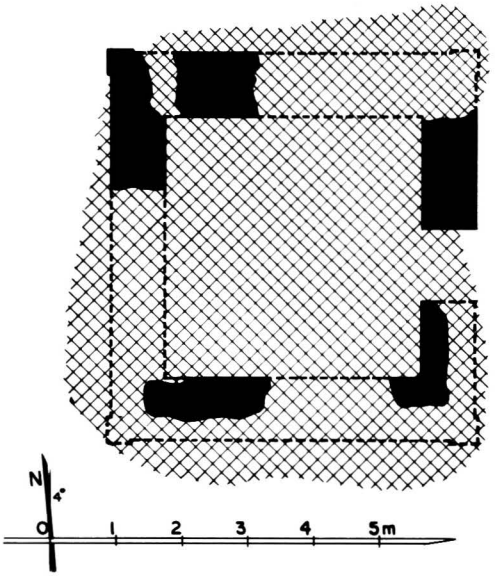
470 a - Plan

5 present condition
- ruined.
- vault and roof collapsed.
- ground floor buried under debris.

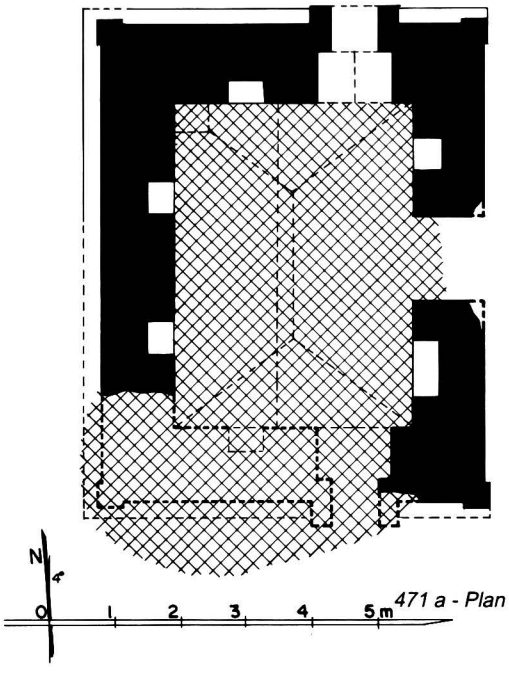
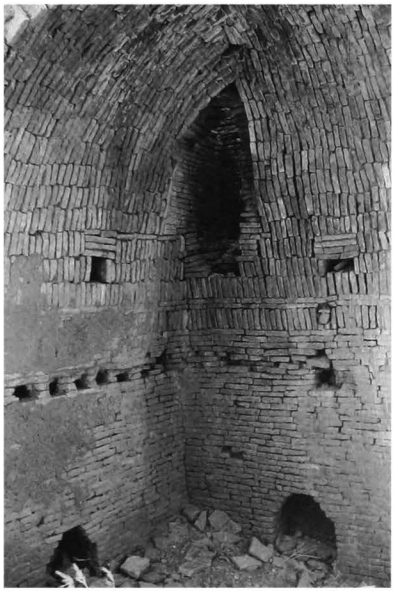
471 a - Plan

5 present condition
- half-ruined.
- south-west corner collapsed.
- ground floor buried under debris.

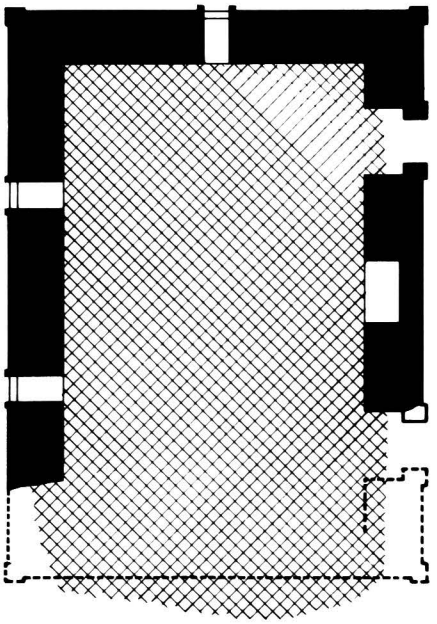
472 a - Plan

5 present condition
- ruined.
- south wall and roof collapsed.
- ground floor buried under debris.

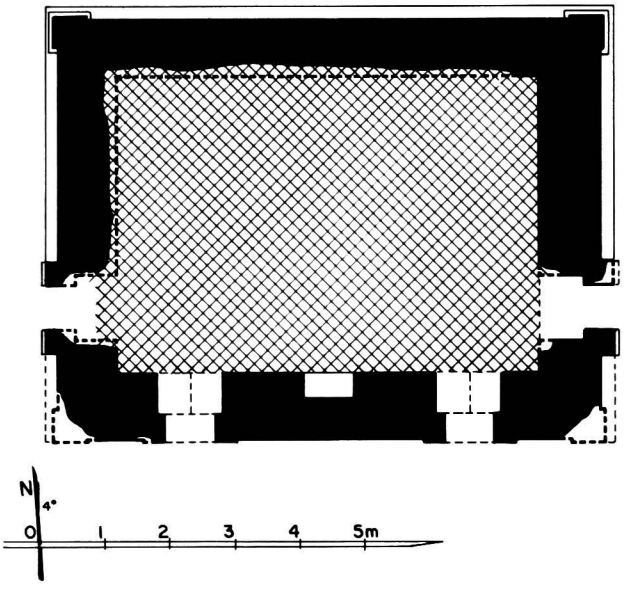
476 a - Plan

5 present condition
- ruined.
- vault and roof collapsed.
- ground floor buried under debris.

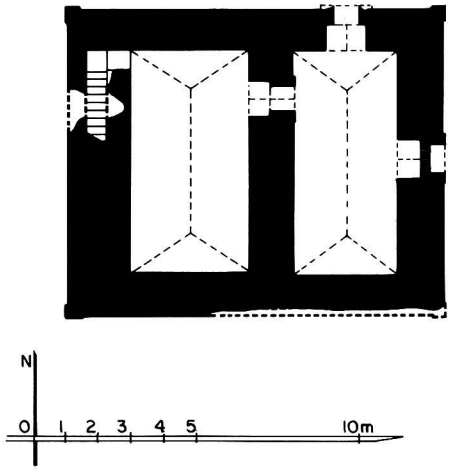
481 - Plan

5 present condition
- half-ruined.

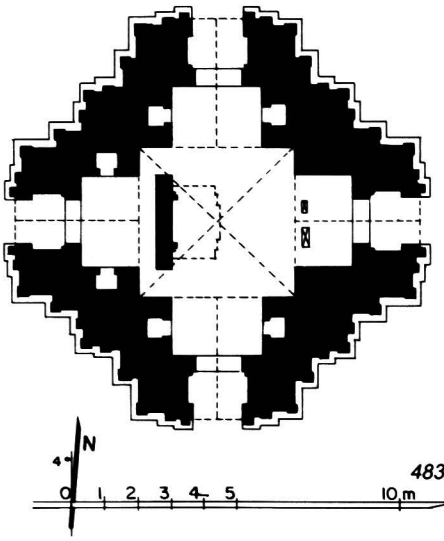
483 a - Plan

5 present condition
- no maintenance.
- base disintegrating.
- repaired (Dept.) 1982.
- brick grilles built by Dept.

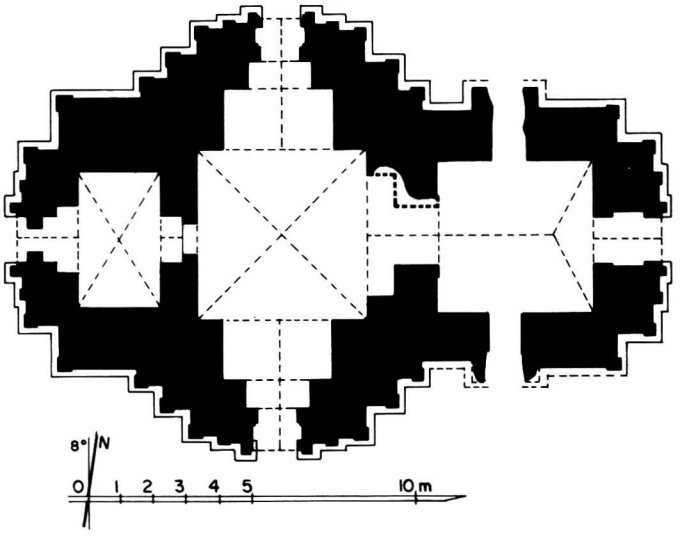
484 a - Plan

5 present condition
- half-ruined.
- base disintegrating.
- vaults and upper parts collapsed.

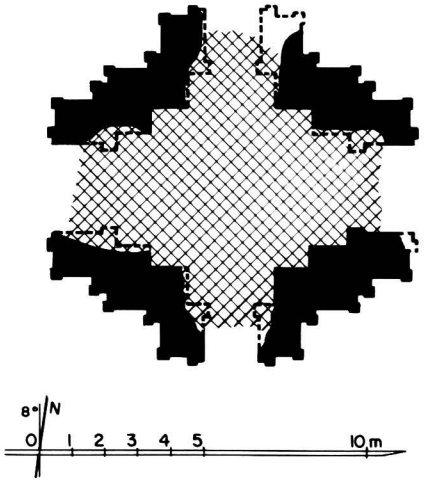
485 a - Plan

5 present condition
- ruined.
- base disintegrated.
- vaults and upper parts collapsed.
- ground floor buried under debris.

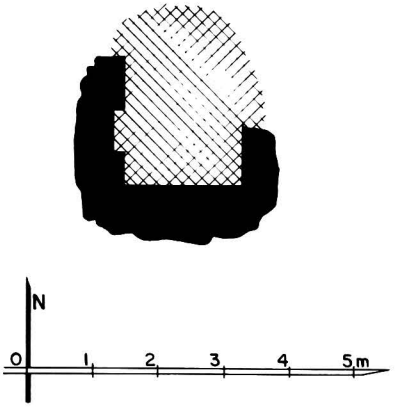
488 a - Plan

5 present condition
- ruined.
- base disintegrated.
- vaults and upper parts collapsed.
- ground floor buried under debris.

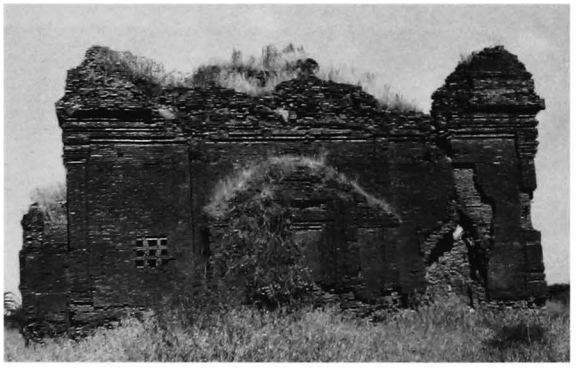
490 b - South face (1984)

5 present condition
- half-ruined.
- east part collapsed during the 1975 earthquake.
- south-east corner collapsed 1986.

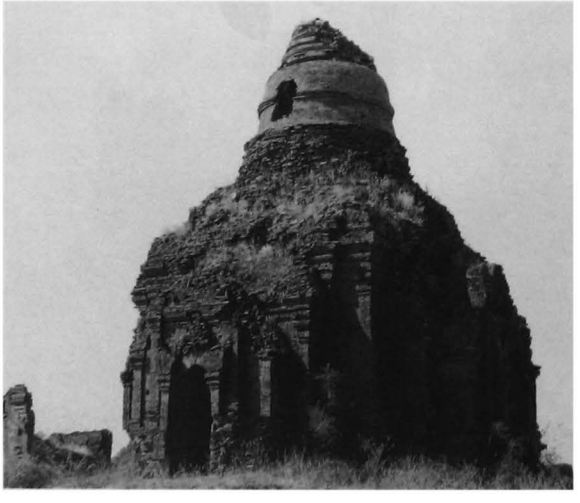
494 b - From north-east

5 present condition
- no maintenance.
- terraces badly damaged.

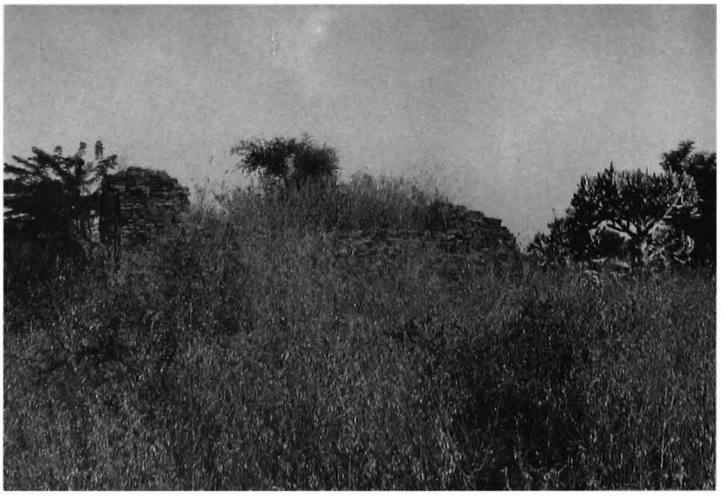
498 b - From south

5 present condition
- ruined.
- only base of walls remains.
- ground floor buried under debris.
